Damage by the 2011 Great East Japan earthquake

Damage by the 2011 Great East Japan Earthquake

Masakatsu Miyajima
Kanazawa University, Japan

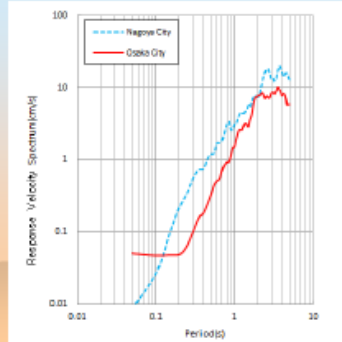
Response velocity spectra at Nagoya and Osaka

- If sloshing of water in receiving water tank is occurred by an earthquake, draw of water to receiving water tank from pipeline starts by error of sensor of water level in the receiving water tank. Sloshing of water in receiving water tank, therefore, seems to be one of the causes of unusual phenomena.
